Service: Full Home Inspection

WIN Inspector

Site Address: 7629 Lake Ballinger Way, Edmonds, WA, 98026

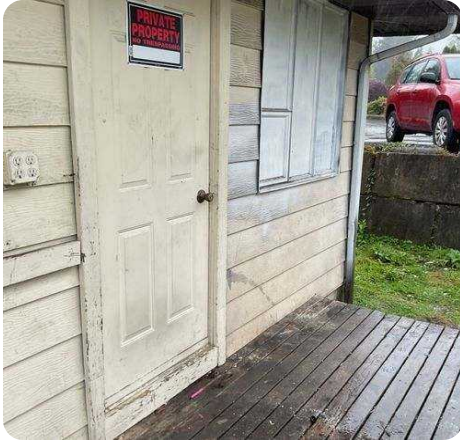
1 Paint And Caulk Satisfactory **🚧 Repairs Recommended**

The exterior paint and caulking material is showing its age, painting by a licensed contractor is recommended.

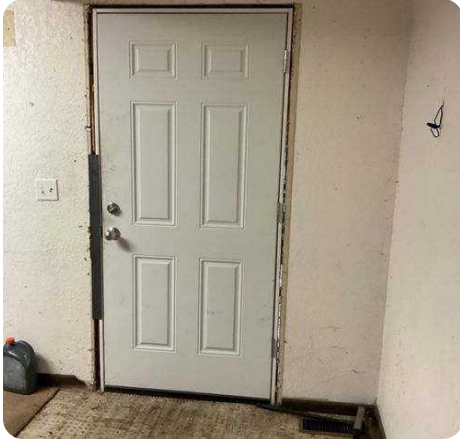
4 Front Door **🚧 Repairs Recommended**

The front door is missing trim, missing weather strip material, needs to be painted, and needs to be adjusted. . It hits the door jamb when closing.

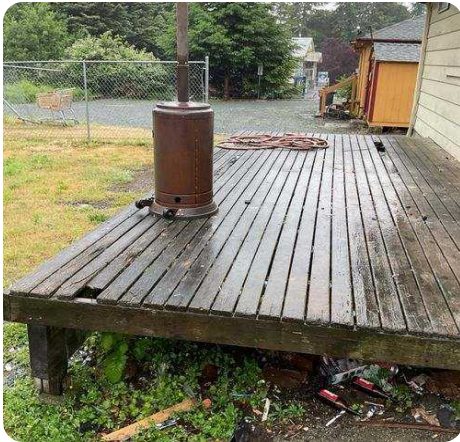
5 Evidence Of Rot

Some of the decking material has rot visible in the wood material which can compromise safety and structural integrity. Recommend replacement of all the damaged material.

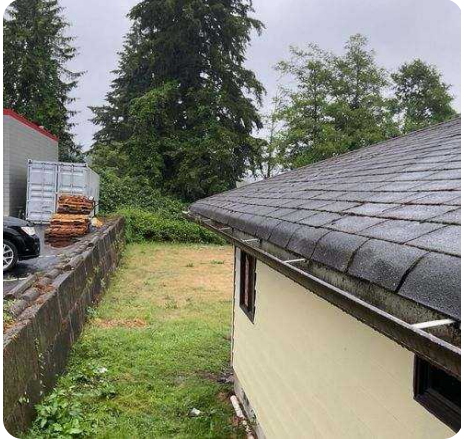
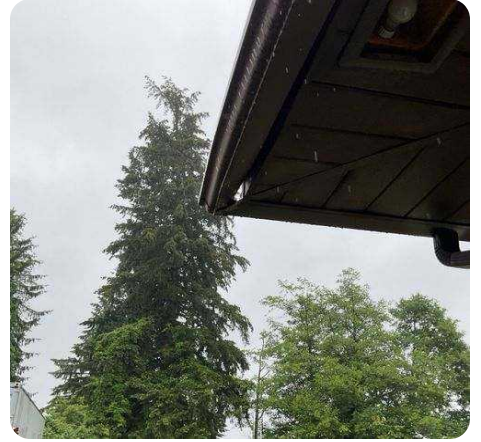
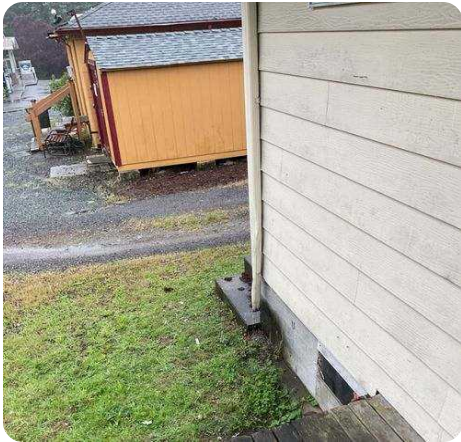
6 Damaged Gutters And Downspouts

The gutters/downspout system on the building needs to be repaired or replaced, the gutters are damaged and leaking in places.

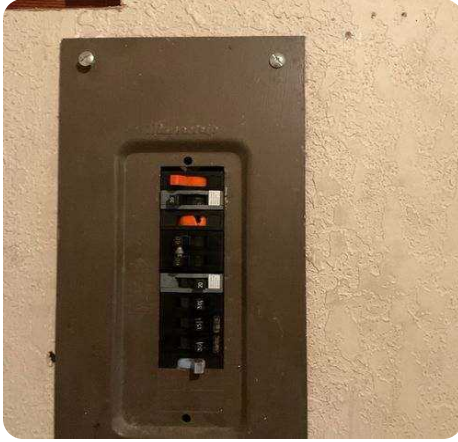
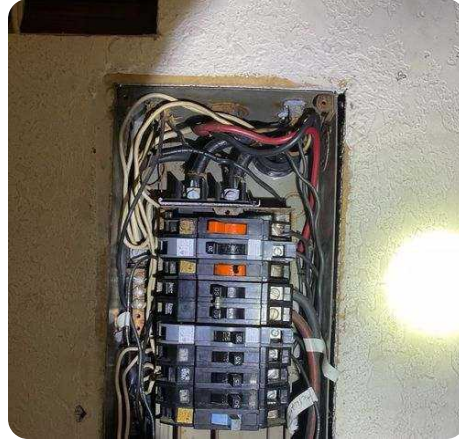
7 Zinsco Panel

The electrical panel is a Zinsco panel, which has a history of safety issues and is considered outdated and potentially unsafe. Also, there is a double tap onto the main feeder, there is under size wiring connected to a 30 amp circuit breaker, and a broken circuit breaker in this electrical panel which are safety concerns. Recommend replacement by a licensed electrician.

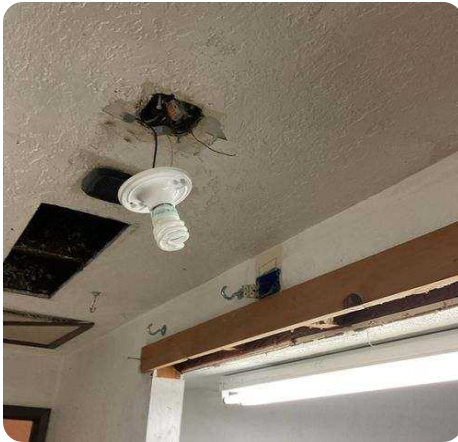
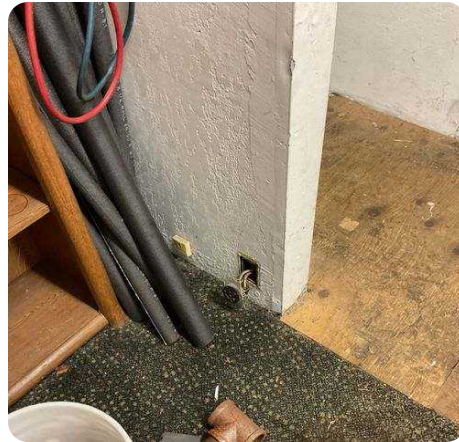
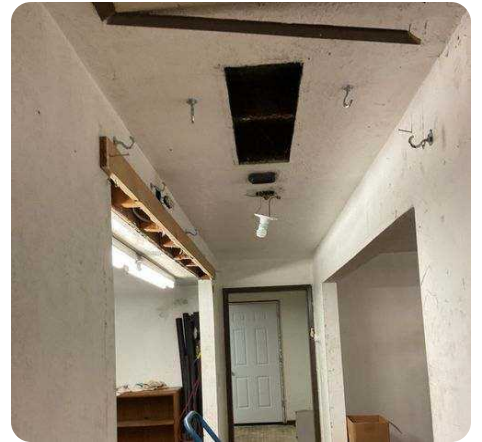
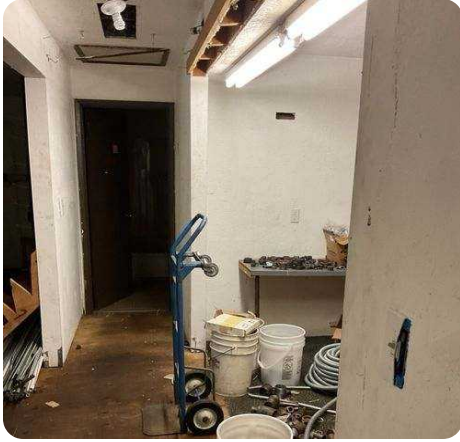
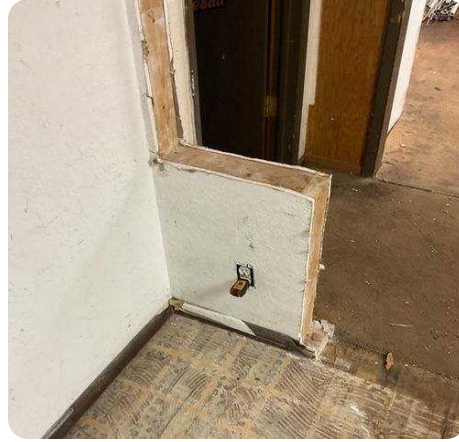
8 Visible Wiring Evaluated

The visible electrical wiring at the property is in need of repair. There are exposed electrical wires showing in most of the rooms, cover plates missing, outlets not working, and light fixtures not working. There were 3 circuit breakers in the off position in the electrical panel which may be part of the problem.

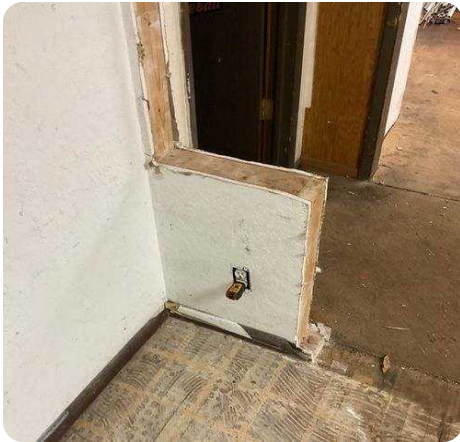
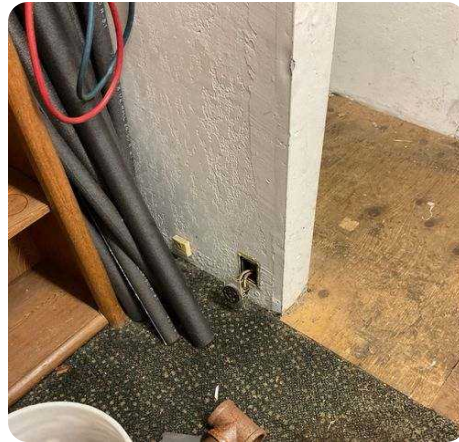
9 Open Grounds

The inspector found 3 prong electrical outlets with "open grounds" and lots of electrical outlets that were not working which may be due to the 3 circuit breakers that were in the off position. It appears that most of the electrical wiring in this building is the original 2 wire non grounded wiring from when it was first built in 1957. Recommended having an electrician evaluate and repair as necessary.

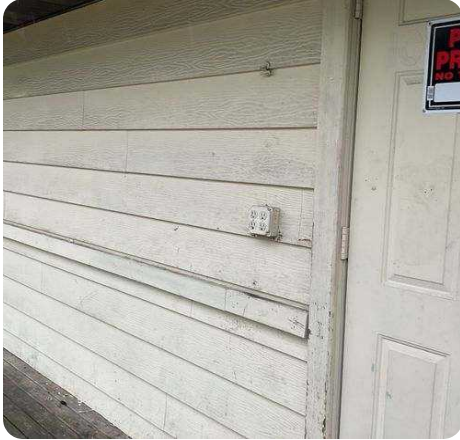
10 Exterior Electrical Outlet

The exterior electrical outlet on the backside of the house is missing the weather cover which is recommended that you replace.

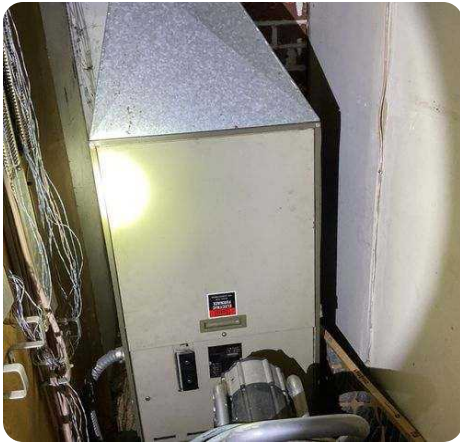
11 Old Electric Furnace

Recommend having the electric furnace serviced and evaluated to determine if it has a reasonable amount of time left before replacement will be necessary. This furnace was working at the time of the inspection, however, it is "old" and is past the normal life expectancy for an electric furnace.

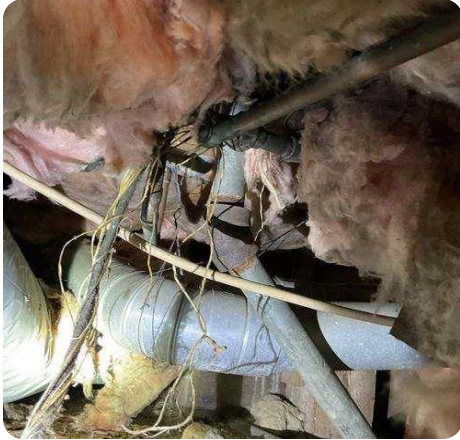
12 Galvanized Pipes Observed

Galvanized pipes were observed in some of the water lines in the bathrooms and the incoming water line from water meter to the building was not located, it may also be galvanized steel. These galvanized steel pipes corrode over time, potentially causing reduced water flow, leaks, and they rust out inside which affects the water quality. Recommend replacement of all the galvanized steel pipes.

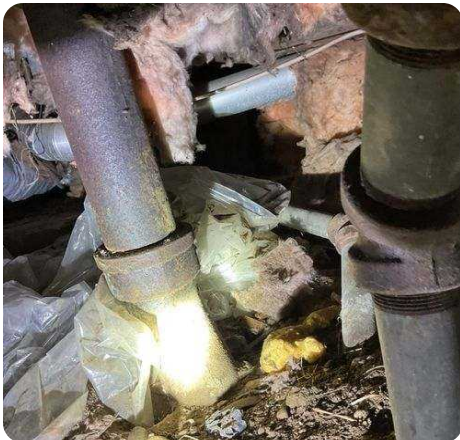
14 Galvanized Steel & Cast Iron

The drain lines that are visible in the crawl space may need to be replaced. There are rusted sections of cast iron drain lines and some galvanized steel sections which may be nearing the end of their live expectancy due to their age. Recommend having a plumber evaluate to see if replacement is necessary now.

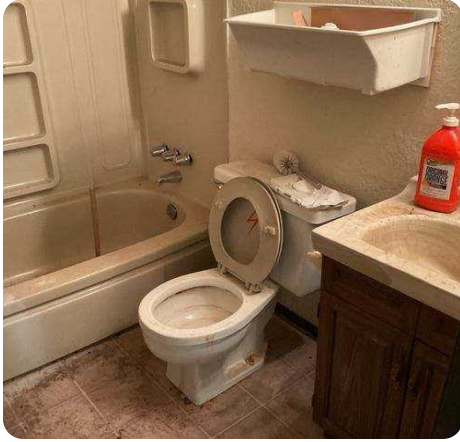
15 Toilets In Bad Condition

The toilet in the NE bathroom was not working and both of these toilets have seen better days. . . Recommend replacement.

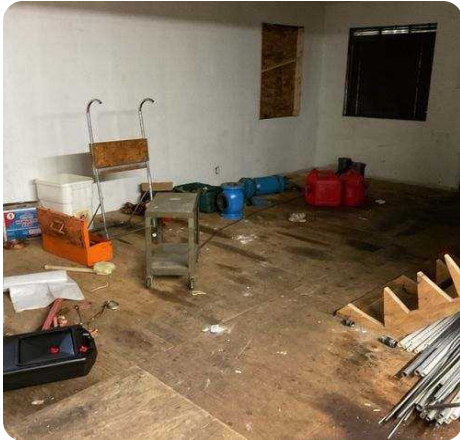
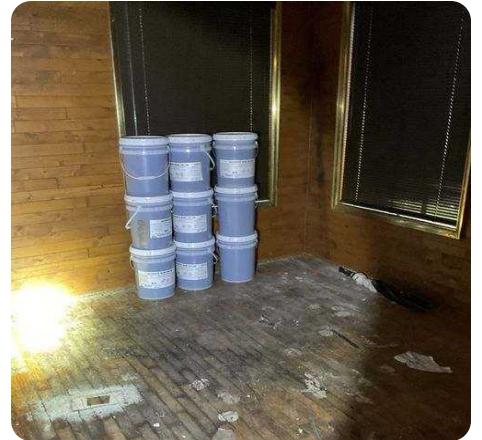
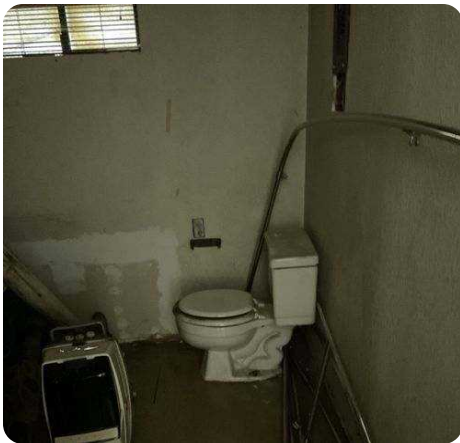
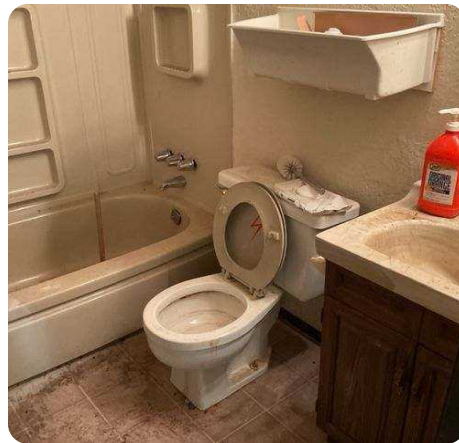
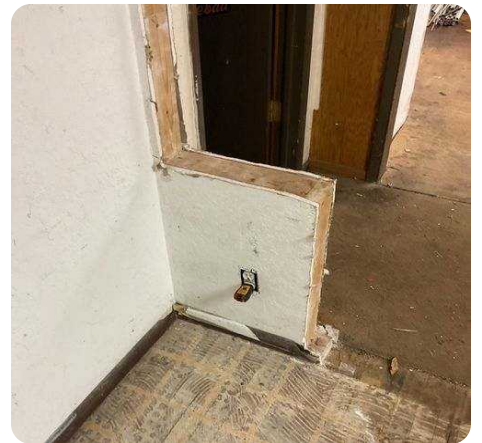
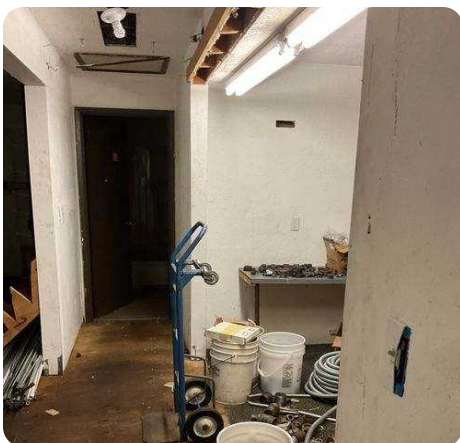
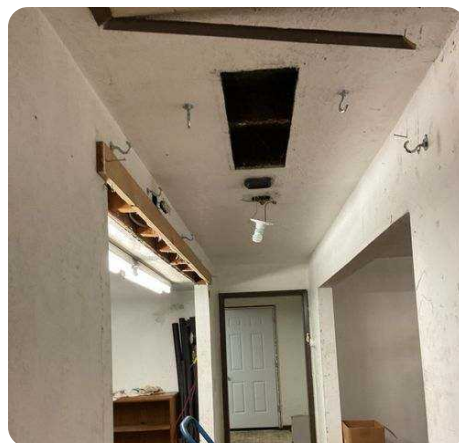
18 New Interior Needed

The interior of this building needs everything. . . Drywall repair, new paint, new interior doors and trim, and all new flooring material.

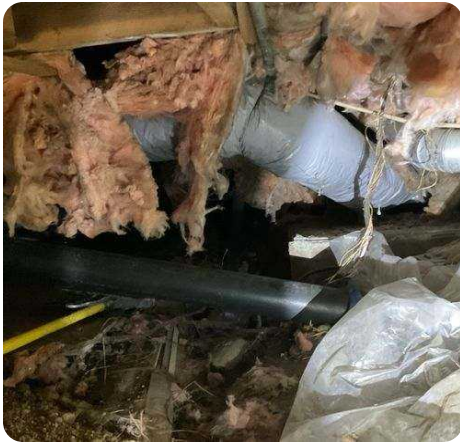
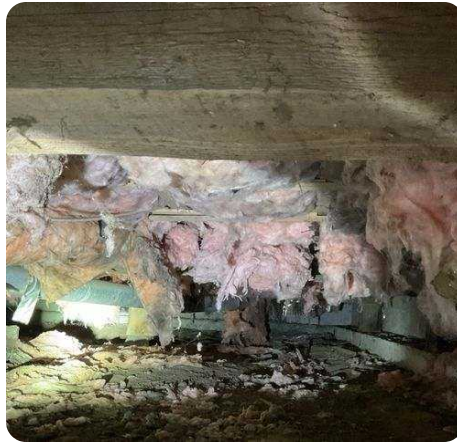
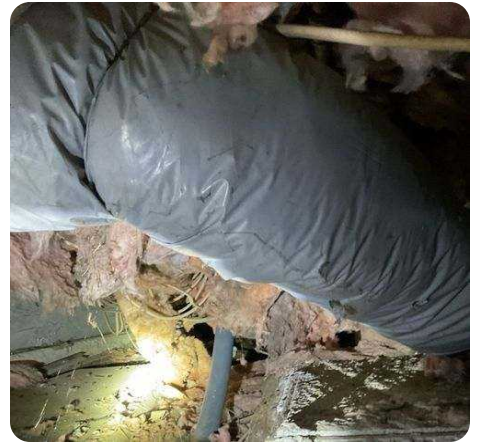
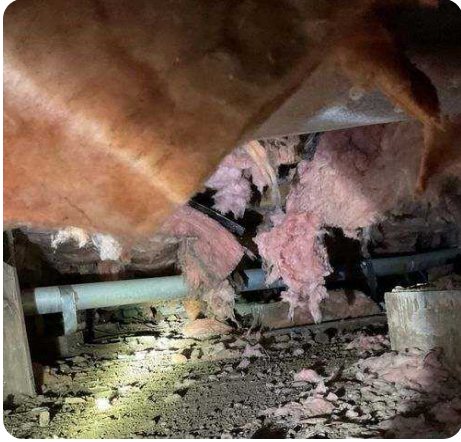
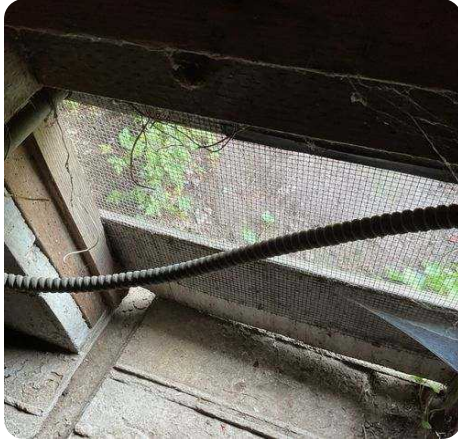
22 Rodent Activity 🔧 Repairs Recommended

There is rodent activity in the crawl space. The plastic vapor barrier, all of the underfloor insulation, and the insulation that is wrapping the heating ducts needs to be replaced due to rodent damage. The inspector saw openings under the crawl space vent screen on the backside of the building which is one place the rodents are entering from that needs to be filled.

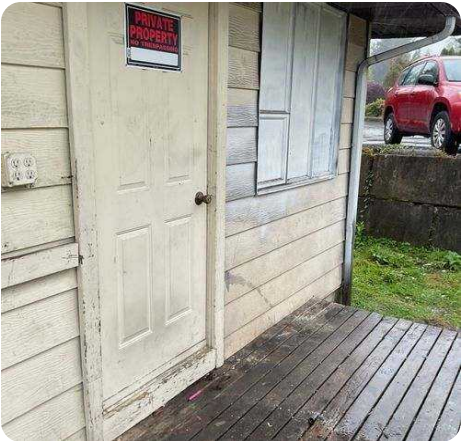
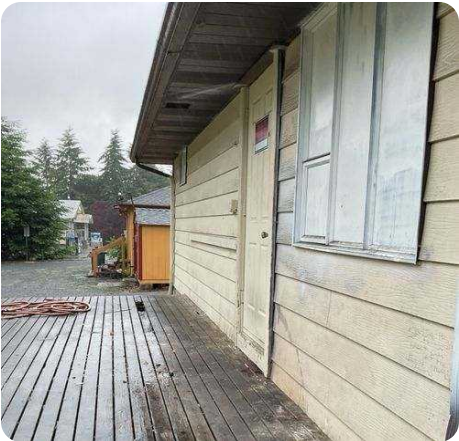
1.2 Exterior > Paint/Coating and Caulking

The exterior paint and caulking material is showing its age, painting by a licensed contractor is recommended.

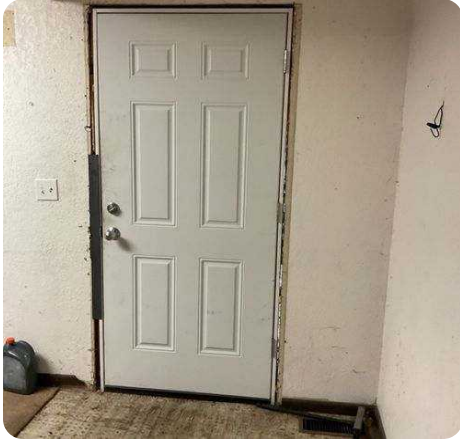
1.6 Exterior > Exterior Doors

The front door is missing trim, missing weather strip material, needs to be painted, and needs to be adjusted. . It hits the door jamb when closing.

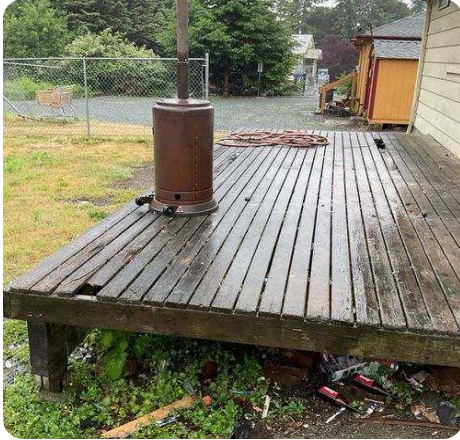
2.1 Decks, Balconies, Paved Surfaces > Deck Installation, Foundation

Some of the decking material has rot visible in the wood material which can compromise safety and structural integrity. Recommend replacement of all the damaged material.

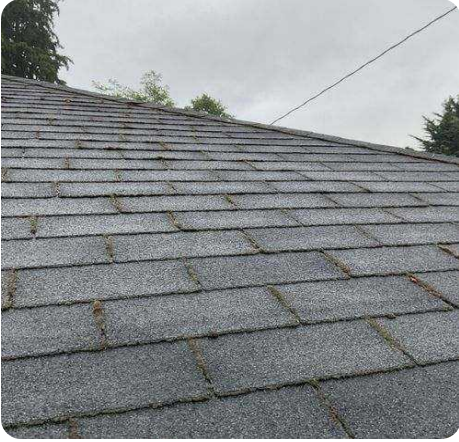
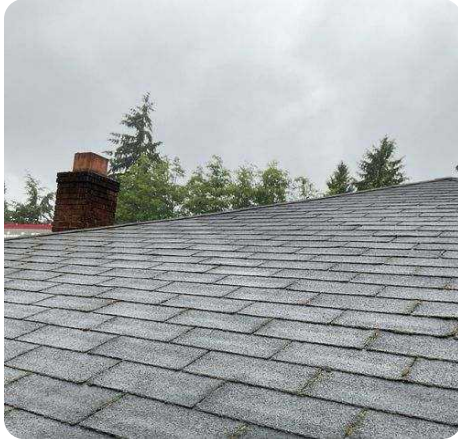
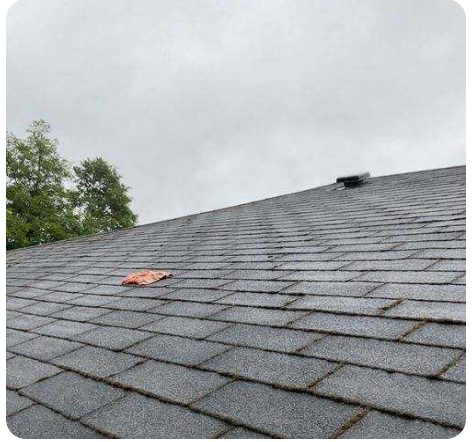
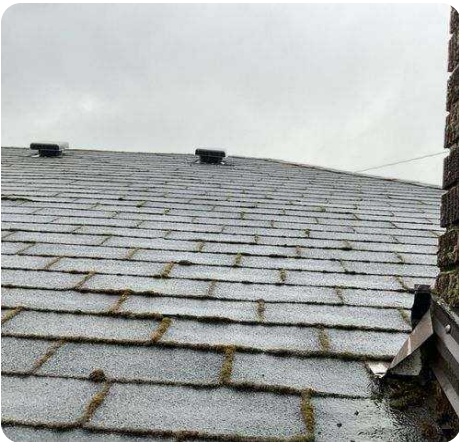
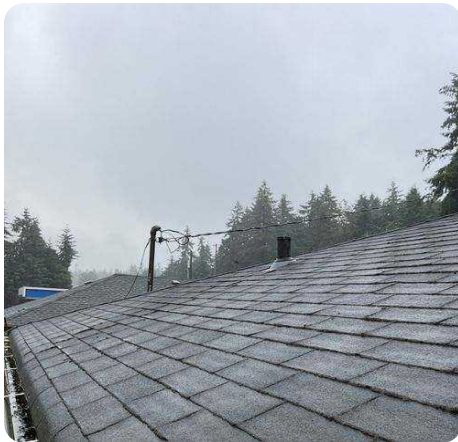
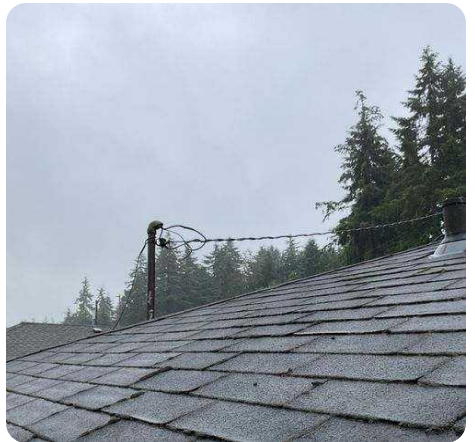
3.1 Roof > Roof Covering

The roofing material appears to be functional; however, it shows signs of aging. It appears that it has about 5 years left before replacement will be necessary, unable to determine the exact number of years of serviceable life left in the material.

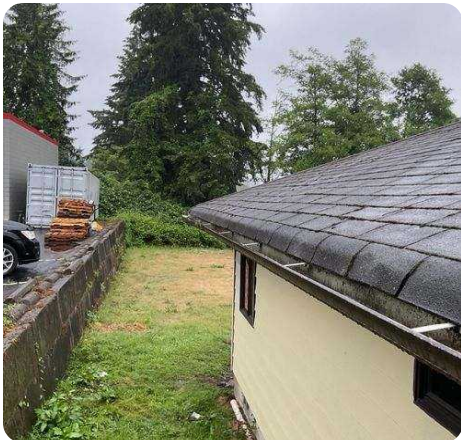
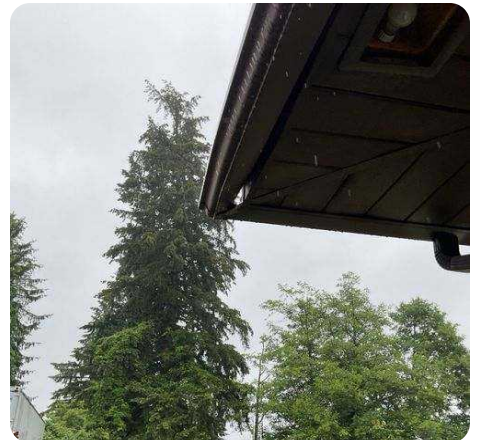
3.4 Roof > Gutters, Downspouts, and Drainage

The gutters/downspout system on the building needs to be repaired or replaced, the gutters are damaged and leaking in places.

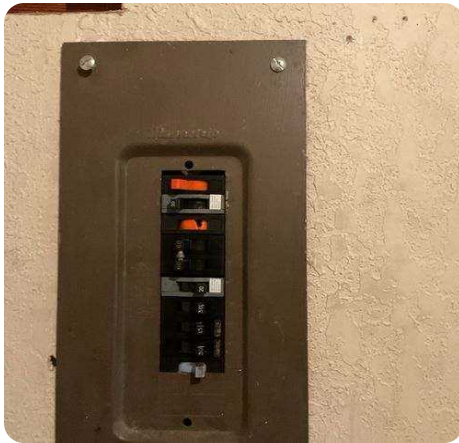
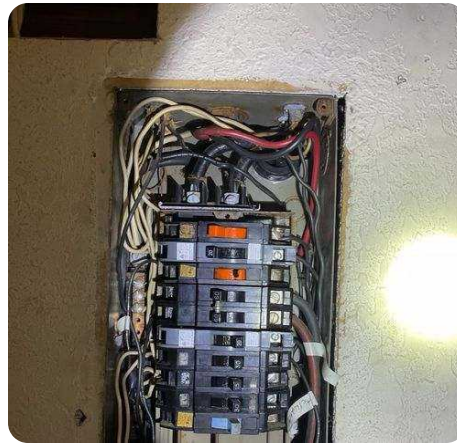
4.2 Electrical > Main Service Panels and Disconnects

The electrical panel is a Zinsco panel, which has a history of safety issues and is considered outdated and potentially unsafe. Also, there is a double tap onto the main feeder, there is under size wiring connected to a 30 amp circuit breaker, and a broken circuit breaker in this electrical panel which are safety concerns. Recommend replacement by a licensed electrician.

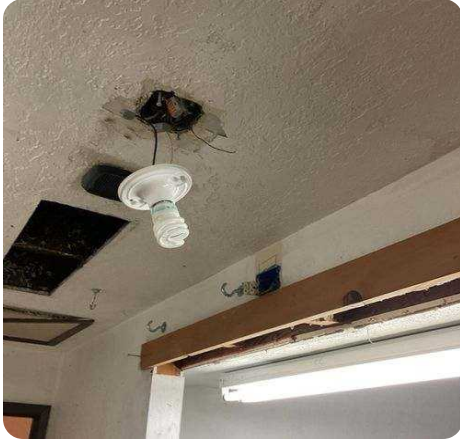
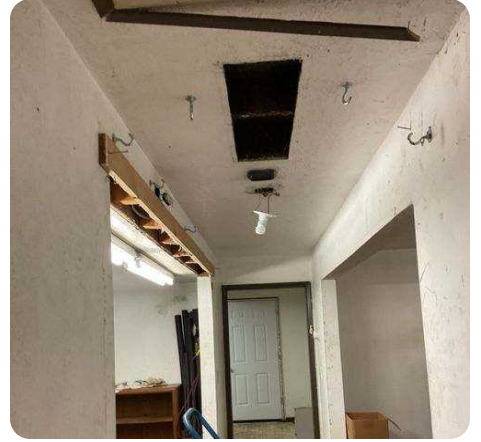
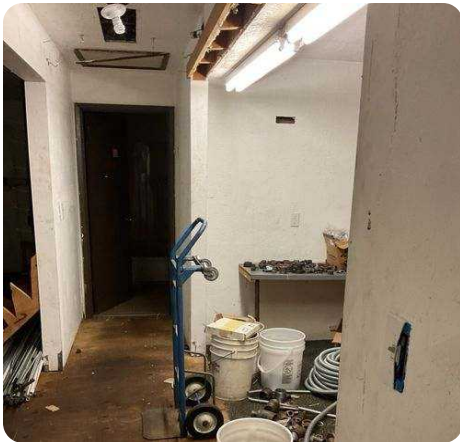
4.3 Electrical > Wiring

The visible electrical wiring at the property is in need of repair. There are exposed electrical wires showing in most of the rooms, cover plates missing, outlets not working, and light fixtures not working. There were 3 circuit breakers in the off position in the electrical panel which may be part of the problem.

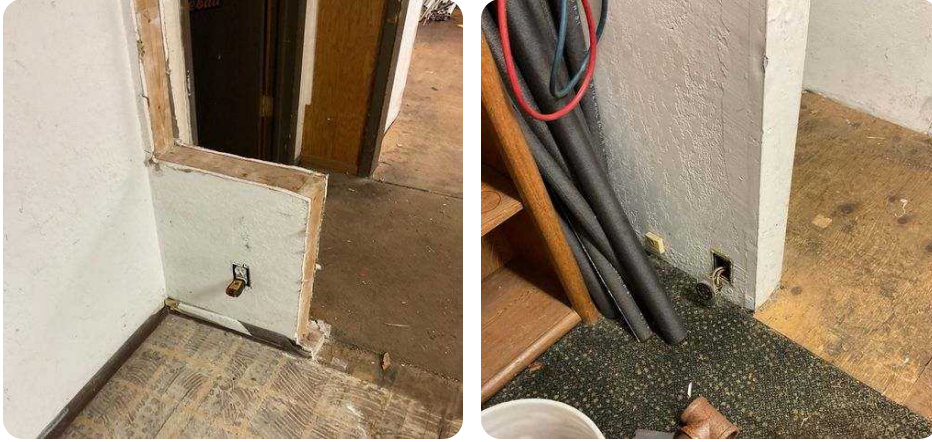
4.4 Electrical > Fixtures, Switches, and Receptacles

The inspector found 3 prong electrical outlets with "open grounds" and lots of electrical outlets that were not working which may be due to the 3 circuit breakers that were in the off position. It appears that most of the electrical wiring in this building is the original 2 wire non grounded wiring from when it was first built in 1957. Recommended having an electrician evaluate and repair as necessary.

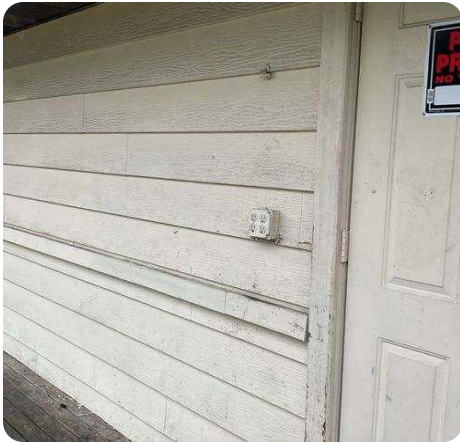
4.5 Electrical > Additional Information

The exterior electrical outlet on the backside of the house is missing the weather cover which is recommended that you replace.

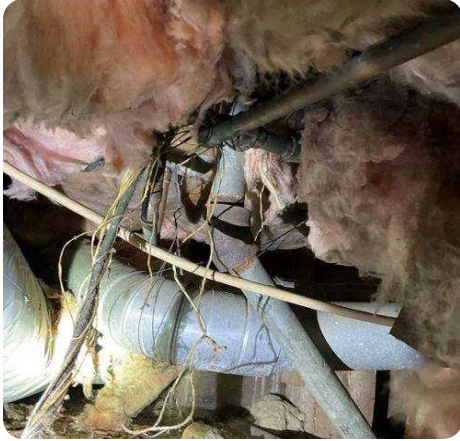
6.1 Plumbing > Water Supply and Piping

Galvanized pipes were observed in some of the water lines in the bathrooms and the incoming water line from water meter to the building was not located, it may also be galvanized steel. These galvanized steel pipes corrode over time, potentially causing reduced water flow, leaks, and they rust out inside which affects the water quality. Recommend replacement of all the galvanized steel pipes.

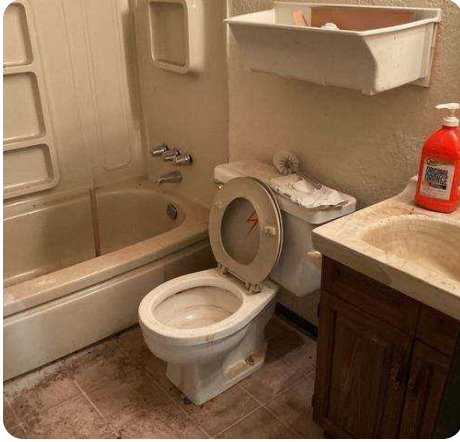
6.4 Plumbing > Toilets

The toilet in the NE bathroom was not working and both of these toilets have seen better days. . . Recommend replacement.

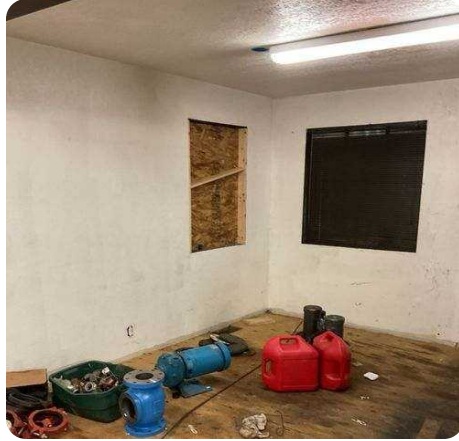
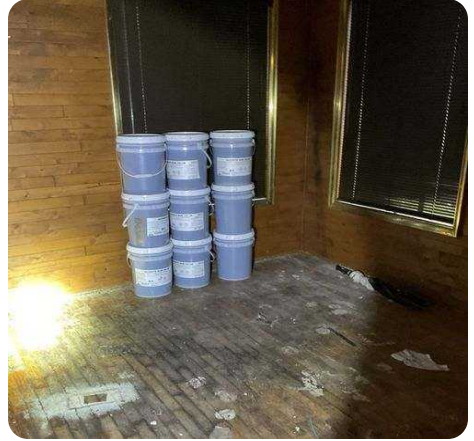
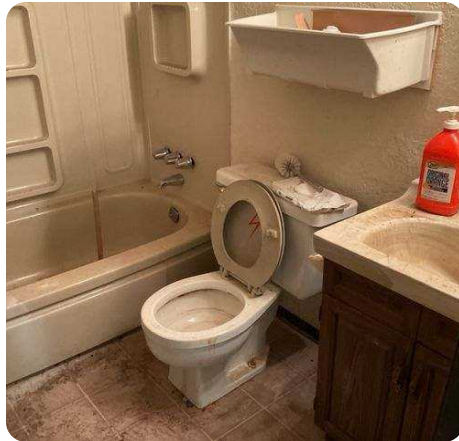
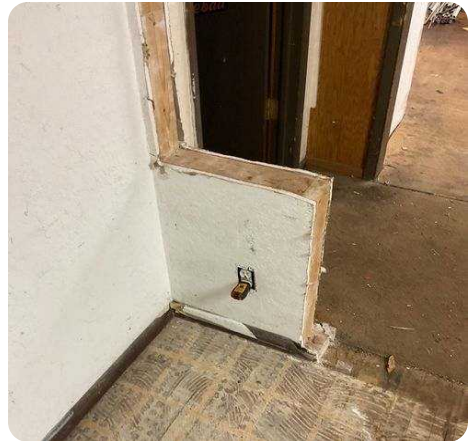
8.1 Interior > Walls, Ceilings, and Floors

The interior of this building needs everything. . . Drywall repair, new paint, new interior doors and trim, and all new flooring material.

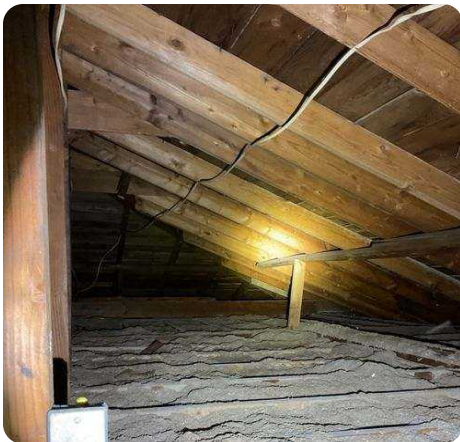
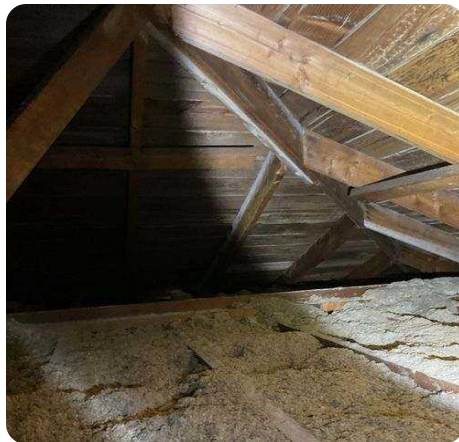
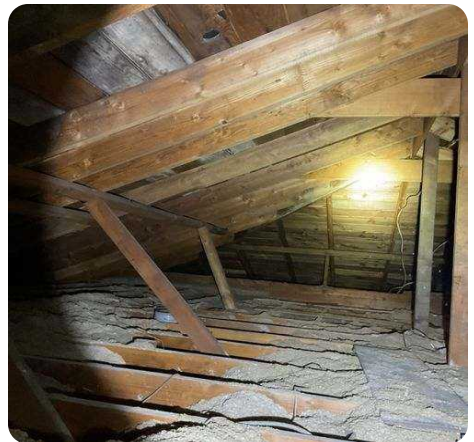
11.1 Insulation and Ventilation > Insulation and Ventilation in Attic

The insulation inside the attic has not been upgraded over the years, there appears to R 19 installed. Recommend upgrading the insulation in the future to R 49 which is the newest insulation standard to help save on the heating and cooling costs. Additionally, passive ventilation in the area appears to be good, the underside of the roof sheeting is very clean.

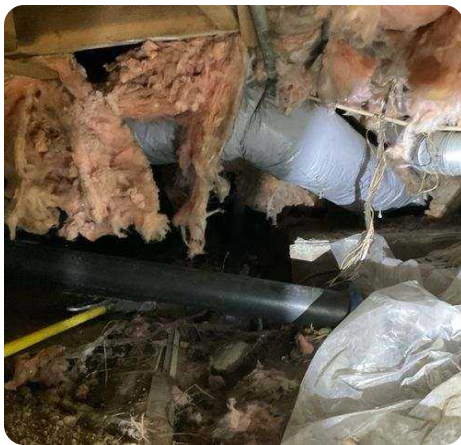
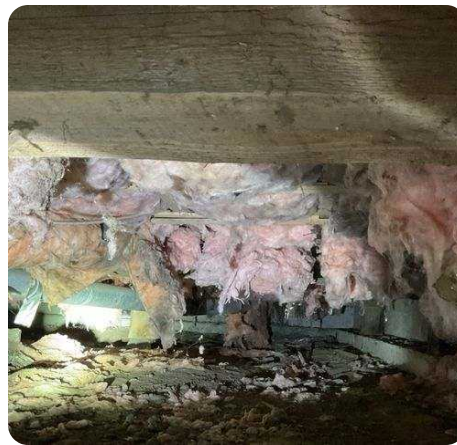
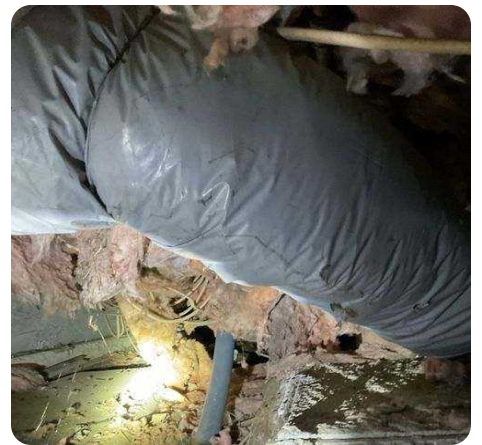
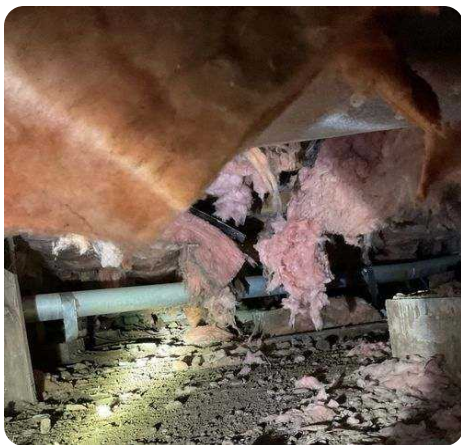
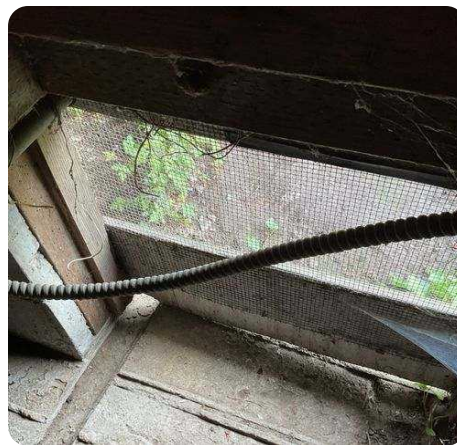
11.2 Insulation and Ventilation > Insulation and Ventilation in Crawl Space

There is rodent activity in the crawl space. The plastic vapor barrier, all of the underfloor insulation, and the insulation that is wrapping the heating ducts needs to be replaced due to rodent damage. The inspector saw openings under the crawl space vent screen on the backside of the building which is one place the rodents are entering from that needs to be filled.
