Service: Full Home Inspection

WIN Inspector

Site Address: 7629 Lake Ballinger Way, Edmonds, WA, 98026

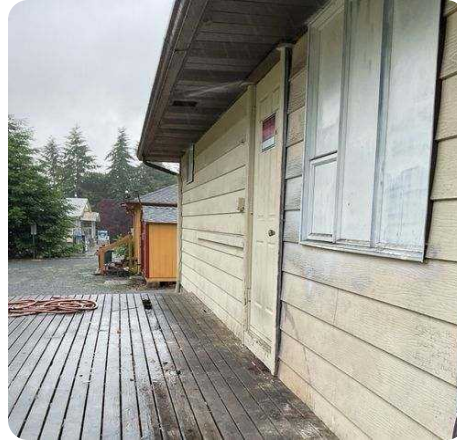
1 Paint And Caulk Satisfactory **🚧 Repairs Recommended**

The exterior paint and caulking material is showing its age, painting by a licensed contractor is recommended.

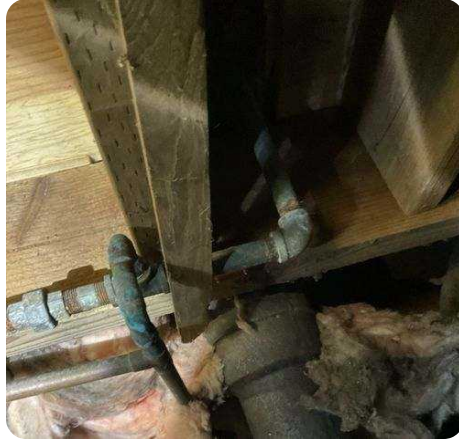
12 Galvanized Pipes Observed

Galvanized pipes were observed in some of the water lines in the bathrooms and the incoming water line from water meter to the building was not located, it may also be galvanized steel. These galvanized steel pipes corrode over time, potentially causing reduced water flow, leaks, and they rust out inside which affects the water quality. Recommend replacement of all the galvanized steel pipes.

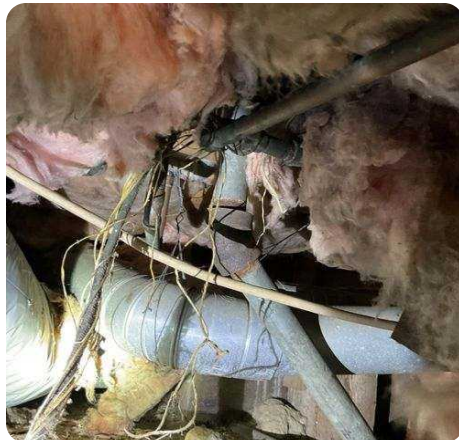
The drain lines that are visible in the crawl space may need to be replaced. There are rusted sections of cast iron drain lines and some galvanized steel sections which may be nearing the end of their live expectancy due to their age. Recommend having a plumber evaluate to see if replacement is necessary now.

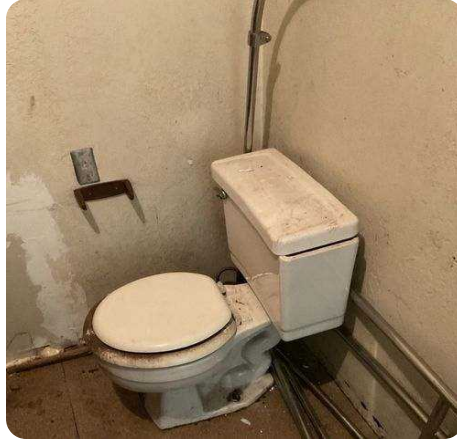
15 Toilets In Bad Condition

The toilet in the NE bathroom was not working and both of these toilets have seen better days. . . Recommend replacement.

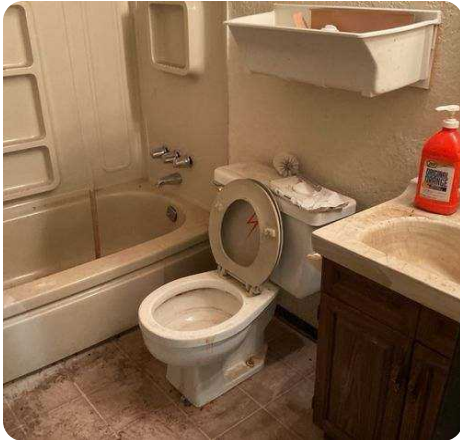
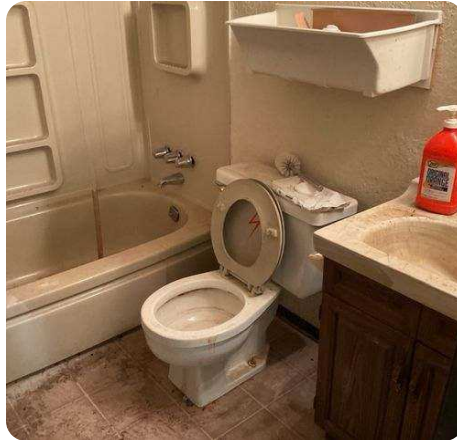
16 Bathtub/Shower Not Working

There was no water flow to the bathtub/shower, not sure if the water lines are connected. Also, there was no hot water to the sinks or to the bathtub/shower...no water heater was located.

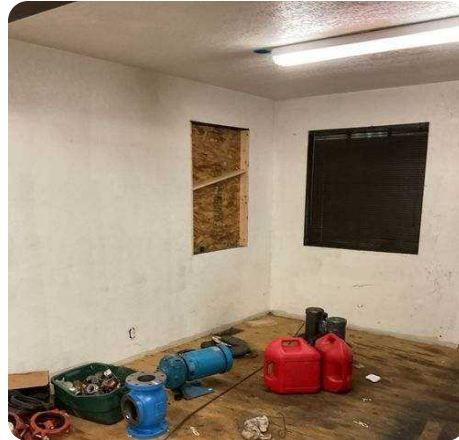
The interior of this building needs everything. . . Drywall repair, new paint, new interior doors and trim, and all new flooring material.

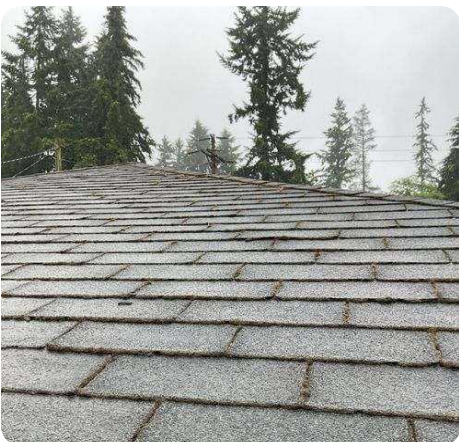
The roofing material appears to be functional; however, it shows signs of aging. It appears that it has about 5 years left before replacement will be necessary, unable to determine the exact number of years of serviceable life left in the material.

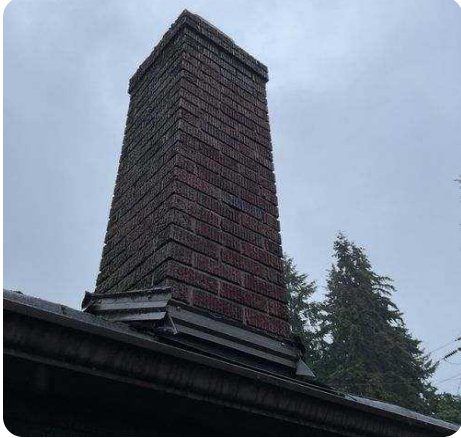
Exterior Chimney Evaluated ✓ Functional

The exterior chimney was evaluated and appeared to be in functional condition (free of any significant defects) at the time of the inspection.

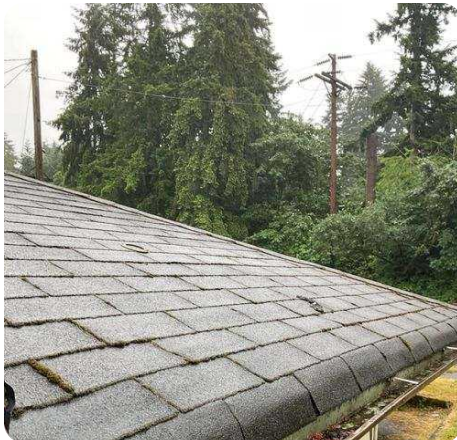
Damaged Gutters And Downspouts

The gutters/downspout system on the building needs to be repaired or replaced, the gutters are damaged and leaking in places.

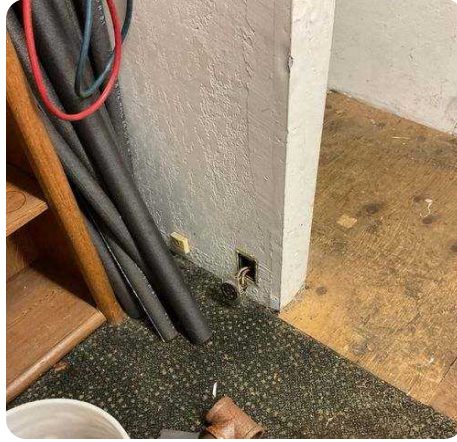
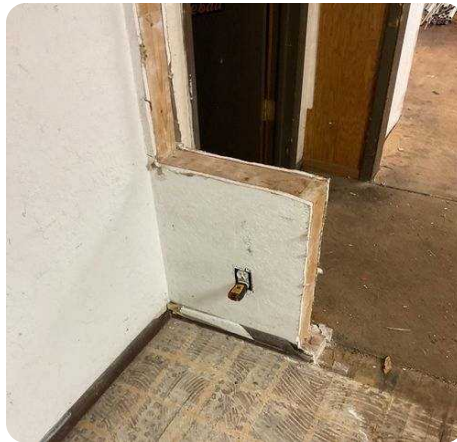
The visible electrical wiring at the property is in need of repair. There are exposed electrical wires showing in most of the rooms, cover plates missing, outlets not working, and light fixtures not working. There were 3 circuit breakers in the off position in the electrical panel which may be part of the problem.

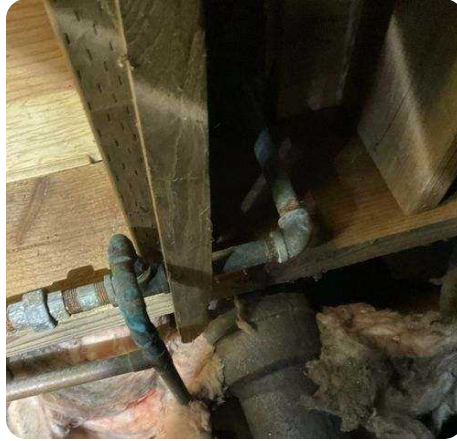
Galvanized Pipes Observed

Galvanized pipes were observed in some of the water lines in the bathrooms and the incoming water line from water meter to the building was not located, it may also be galvanized steel. These galvanized steel pipes corrode over time, potentially causing reduced water flow, leaks, and they rust out inside which affects the water quality. Recommend replacement of all the galvanized steel pipes.

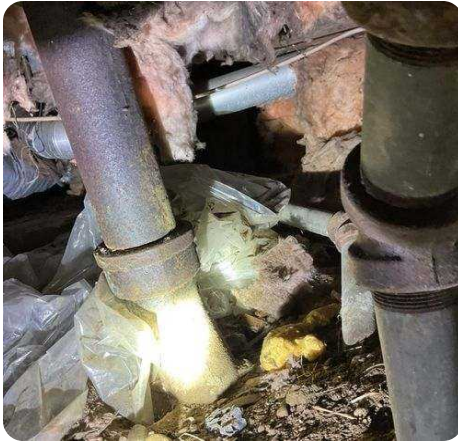
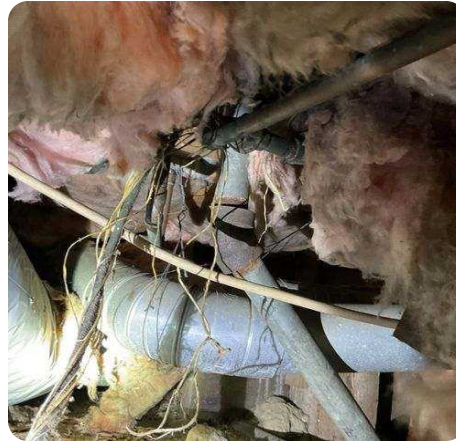
The drain lines that are visible in the crawl space may need to be replaced. There are rusted sections of cast iron drain lines and some galvanized steel sections which may be nearing the end of their live expectancy due to their age. Recommend having a plumber evaluate to see if replacement is necessary now.

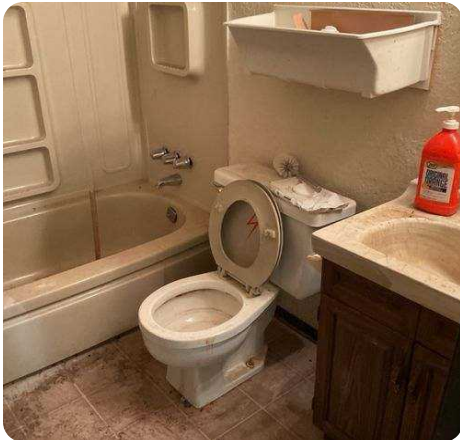
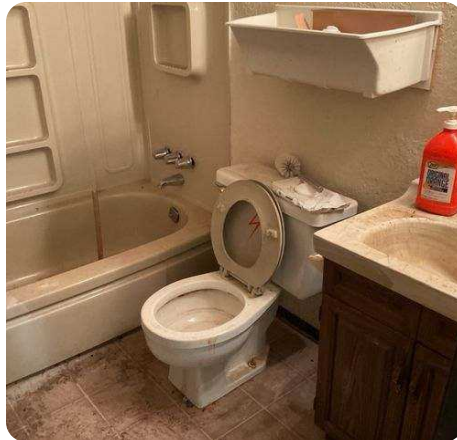
There was no water flow to the bathtub/shower, not sure if the water lines are connected. Also, there was no hot water to the sinks or to the bathtub/shower...no water heater was located.

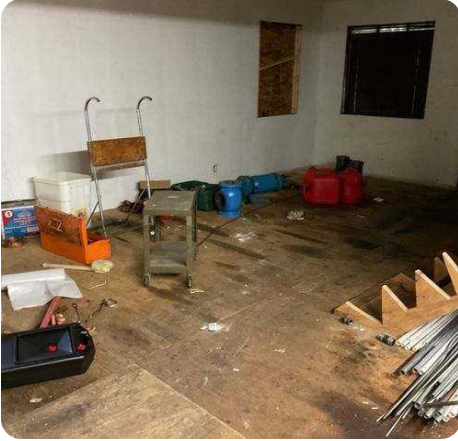
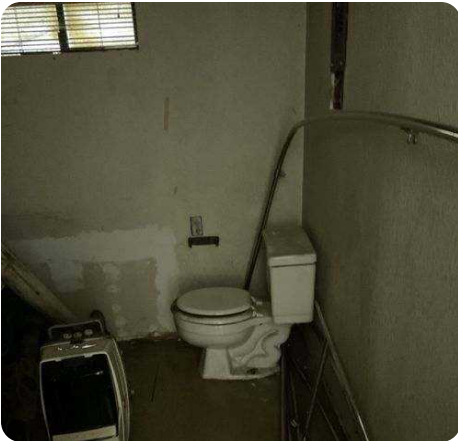
The interior of this building needs everything. . . Drywall repair, new paint, new interior doors and trim, and all new flooring material.
